**Freeport-McMoRan
Chino Mines Company
Hurley, New Mexico**

**Completion Report
Interim Remedial Action
Star Rock Stockpile
Hanover and Whitewater Creeks Investigation Unit**

April 8, 2011

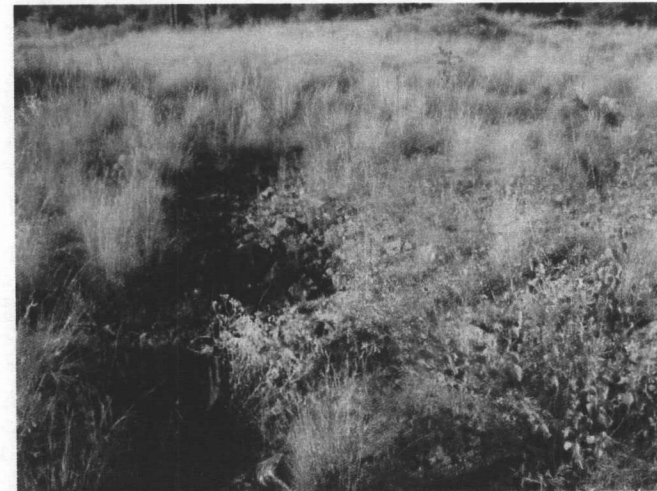
Photo D:
**Small rill at Tenderfoot B beginning to heal (note plants
establishing in the channel)**

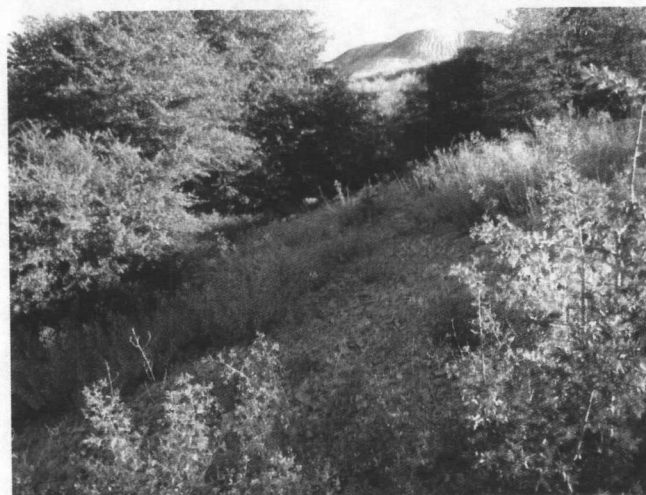
Photo H:
CG Bell site recruiting California brickellbush

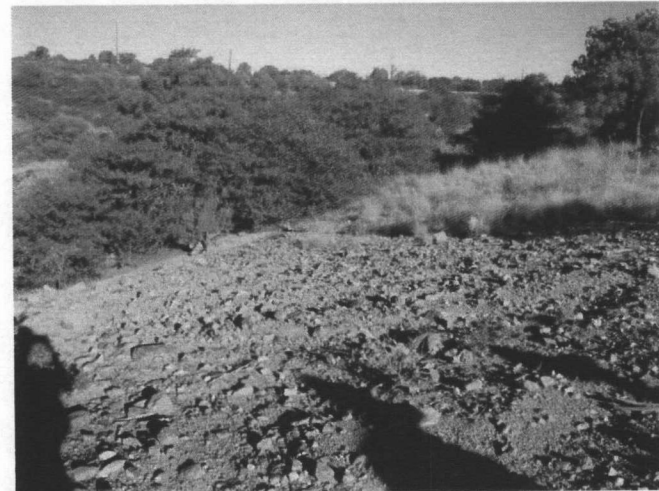
Photo L:
Central section of Osceolla site that has had poor plant establishment

Golder recommends continued annual qualitative monitoring of the vegetation progress of these areas. When all the sites have achieved cover levels that are considered adequate, Golder will complete a formal quantitative survey of the areas to demonstrate that the vegetation has achieved the success targets consistent with the Vegetation Success Standards of Appendix C in the Mining and Minerals Division revision 01-1 to Permit GR000RE.

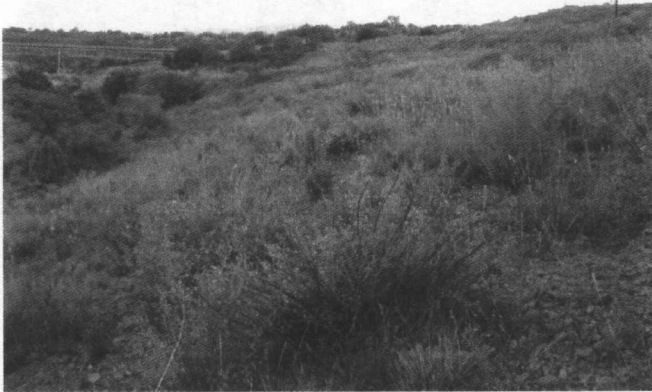
The stockpile was inspected on September 30, 2010, at the end of the summer monsoon season. Originally covered in 1998, the area was not seeded, but native plants have colonized the site. The plant community is in very good condition with an estimated average canopy cover of 45% and an estimated shrub density of 350 stems per acre. A total of 18 species were identified in the plant community, including grasses, forbs, shrubs, and trees (Table 4). This indicates that the soil cover is capable of recruiting and maintaining vegetation that is viable and self sustaining.

Photo M:
Well established plant community at the Star Rock Stockpile

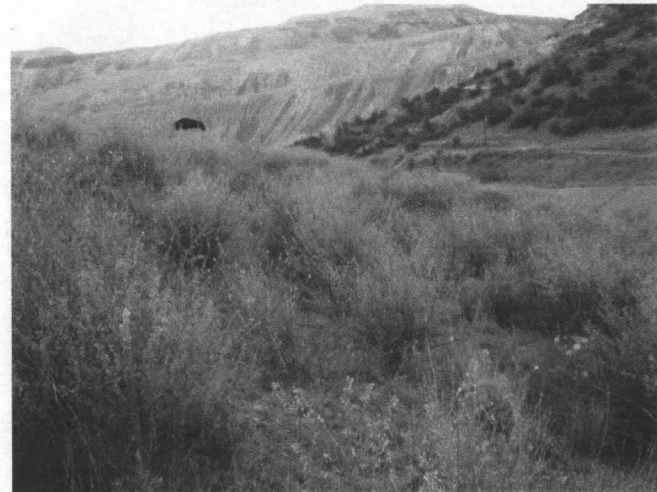
Photo N:
Good cover of California brickellbush and native grasses
at the Star Rock Stockpile

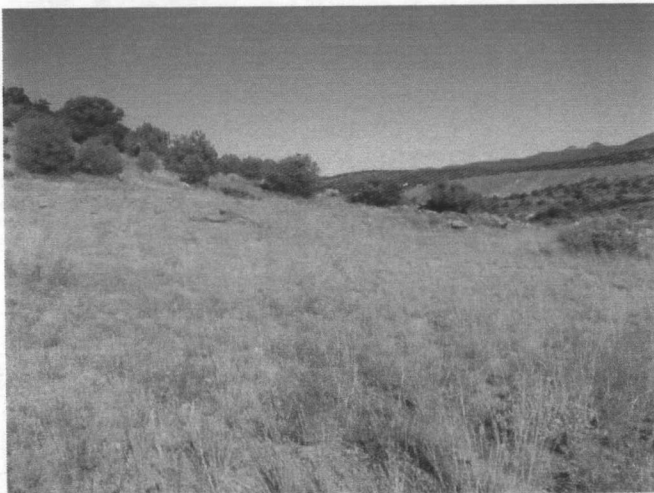
The vegetation in the borrow area at the Groundhog site is generally progressing well (Photos S and T). Plant density exceeds one plant per square foot and is considered appropriate for this stage in the reclamation. Small areas of localized rill erosion were observed in several locations across the borrow area. Many of these rills areas appear to initiate in undisturbed areas upgradient of the borrow site and represent the formation of a natural incipient drainage pattern along the lower slopes.

Photo S:
Groundhog borrow area reclamation

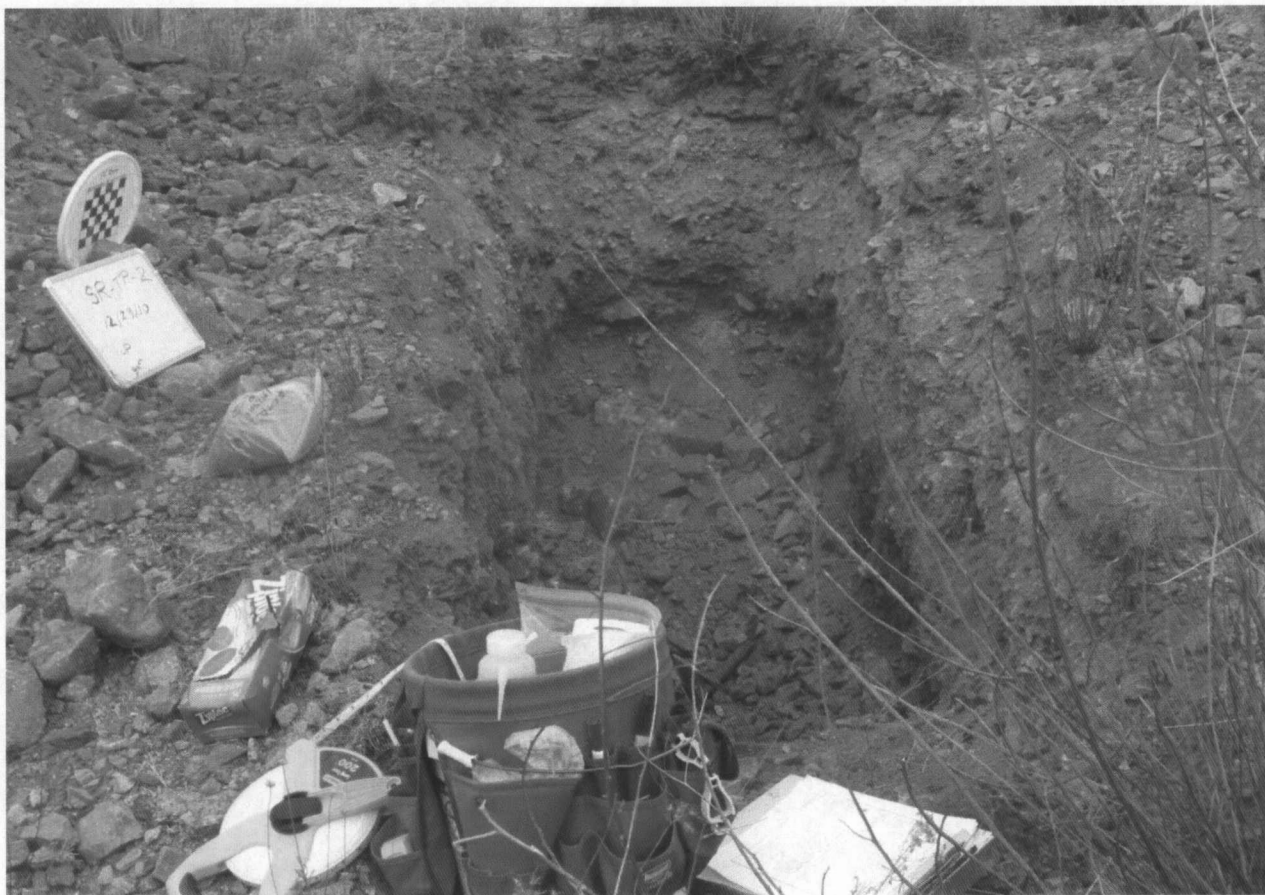
TEST PIT LOG: SR-TP-2

| Depth | USCS | USDA | Description |
|---|---|---|--|
| 0 - 0.5 ft. | SM | Sandy Loam | Silty Sand with Gravel: 5YR 4/2 (dark reddish gray), dry, mod. plasticity, strong HCl reaction, moderately dense roots. USCS: 10% > 1.5 inch, 20% gravel, 55% Sand, 25% fines. Lithology of clasts: Granodiorite |
| 0.5 - 4 | GC | | Clayey Gravel with Sand: reddish brown, dry, mod. plasticity, strong HCl reaction, some roots. USCS: 30% > 1.5 inch, 50% gravel, 35% Sand, 15% fines. Lithology of clasts: Primarily Limestone to 3 feet, mixed Limestone/Granodiorite below 3 feet. |

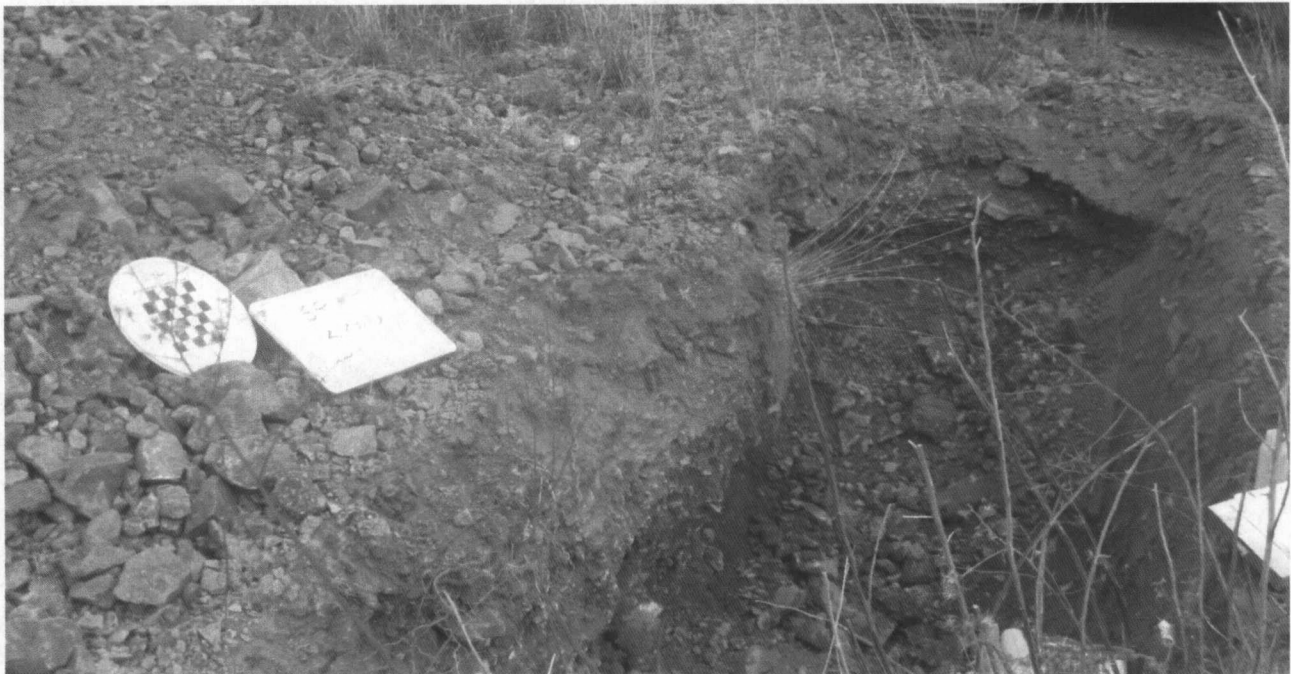
TEST PIT LOG: SR-TP-3

| Depth | USCS | USDA | Description |
|---|---|---|---|
| 0 - 0.5 ft. | SM | Sandy Loam | Silty Sand with Gravel: 5YR 4/2 (dark reddish gray), dry, mod. plasticity, strong HCl reaction, moderately dense roots. USCS: 10% > 1.5 inch, 20% gravel, 55% Sand, 25% fines. Lithology of clasts: Granodiorite |
| 0.5 - 4 | GC | | Clayey Gravel with Sand: grayish to reddish brown, moist, mod. plasticity, strong HCl reaction. USCS: 10% > 1.5 inch, 50% gravel, 30% Sand, 20% fines. Slightly cemented clays, no soil in matrix as in previous pits. Lithology of clasts: Primarily Limestone (>90%) with minor Granodiorite and Shale. |
